**WATERPROOF MARINE VENTILATION SYSTEM
FOR
DRY FREIGHT VAN CONTAINERS**

MARKETING RESEARCH REPORT NO. 988

**Agricultural Research Service
UNITED STATES DEPARTMENT OF AGRICULTURE**

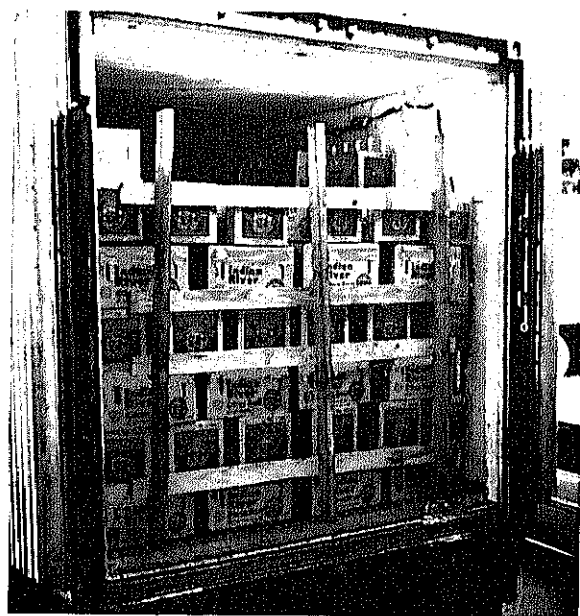
PN-3245

FIGURE 16.—Refrigerated van container at shipping point with grapefruit boxes loaded in USDA's recommended bonded-block pattern. Note wooden endgate in place.

wooden gates at the rear stack (fig. 16). All thermostats in the mechanical refrigeration units on these van containers were set at 60° F. The three loaded refrigerated van containers were transported via piggyback from Vero Beach, Fla., to the port of Norfolk, Va. The ventilated van container was transported over the highway from Vero Beach to the same point.

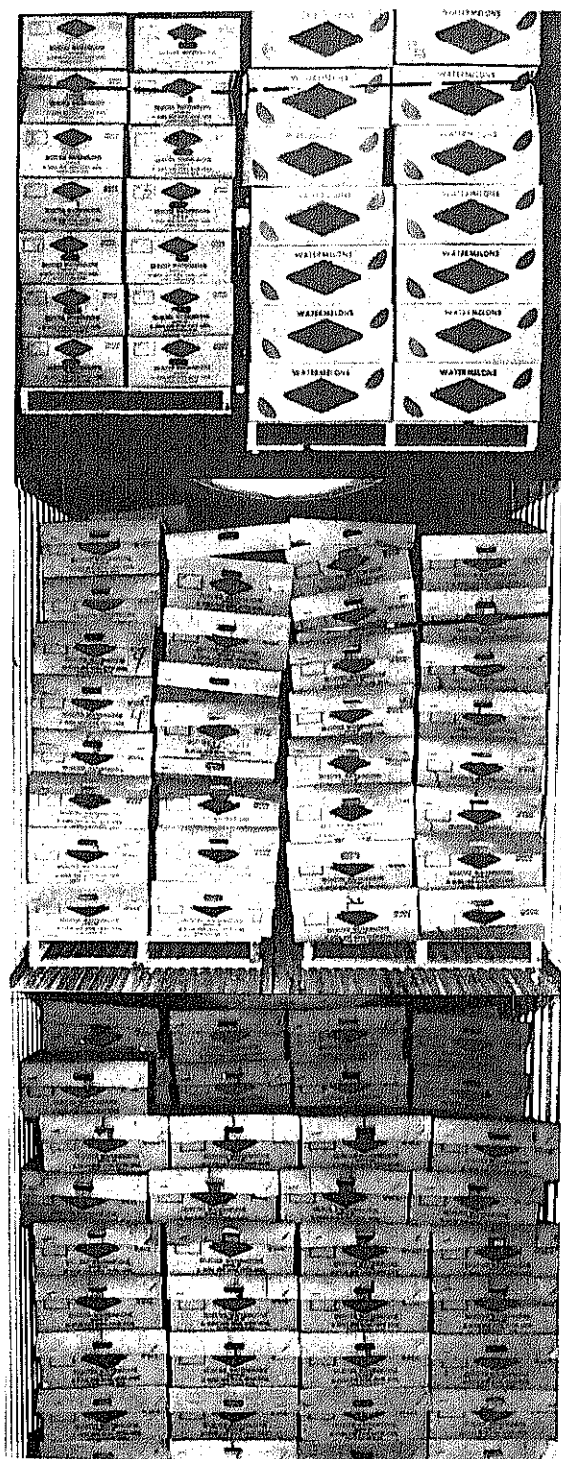
PN-3248, PN-3249, PN-3250
FIGURE 21.—Arrival condition of watermelons in van containers, Florida to London, England, 1971: *Top*, palletized load in ventilated container; *center*, palletized load in refrigerated container; *bottom*, nonpalletized load in refrigerated container.

The arrival condition of the palletized load of watermelons in the ventilated van container was excellent (fig. 21). Less than 2 percent of the melons were found to be damaged upon arrival at the retail level. The bracing at the rear of the load and between the pallets was intact. The corrugated fiberboard boxes used in this load were of double-wall construction and held up well in transit with some slight bulging of the lower layer boxes because of overhead weight. There was no damage associated with the transportation of the melons.
